City of Fort Lauderdale Historic Preservation Design Guidelines

ROOFING

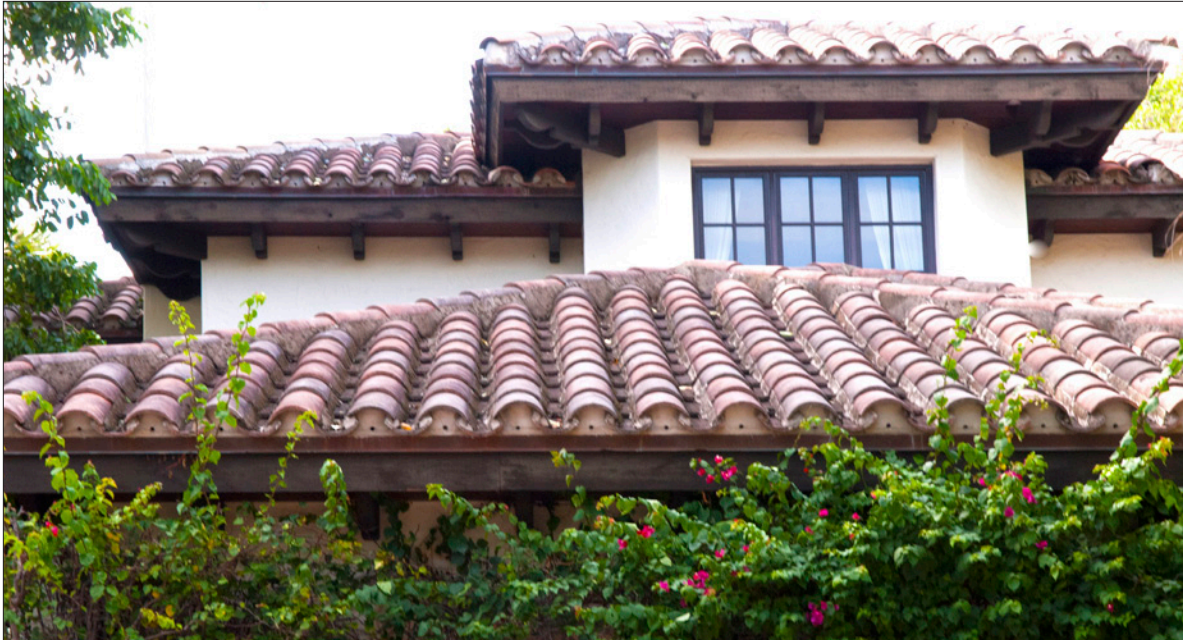
Roofing provides the first line of defense against the elements and greatly affects the overall appearance of a building. The terra cotta roof in this example has a distinctive form, color and texture.

On shallow pitch roofs such as porches, small rectangular pieces of flat seam metal roofing were installed with edges crimped together and soldered to form a weather-tight surface. On steeper pitched roofs, long continuous seams were used, typically in a standing seam configuration, providing regular ridges down roof slopes. Corrugated or other paneled metal roofing, such as 5-V crimp panels were popularized in the 20th century. (Refer to photograph on Page 1.)

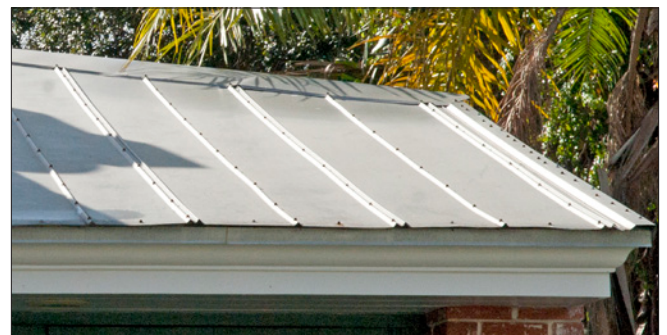
5-V crimp roofing panels were popularized in the mid to late 20th century. They can provide a weather-tight roof system.

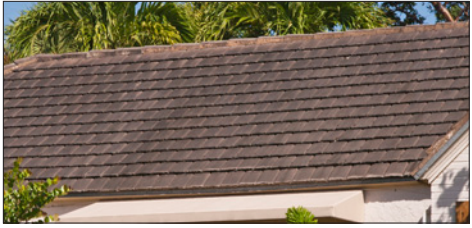
Tile roofing is available in a variety of profiles. These concrete tiles are relatively flat and are similar in appearance to slate roofing.

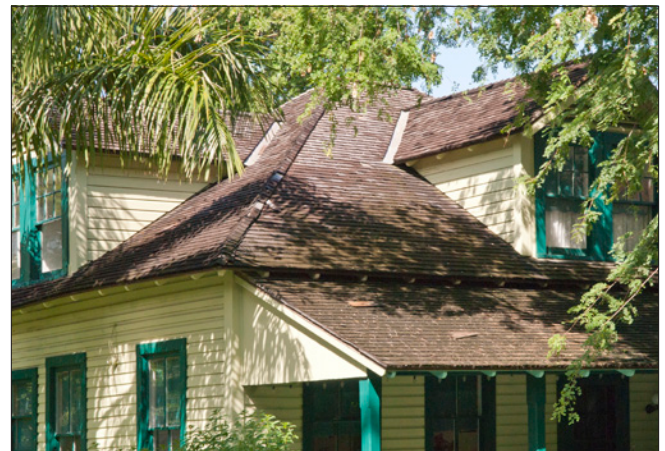
Wood shingle roofs can be found on some of Fort Lauderdale’s oldest homes.

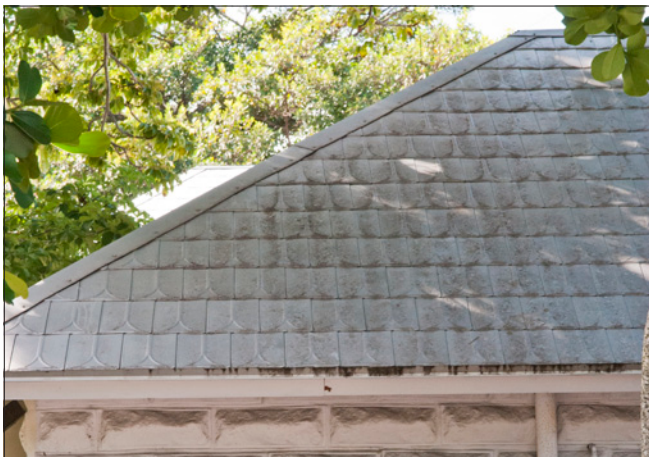
These decorative metal shingles include an embossed pattern on each shingle that adds to the roof's texture.

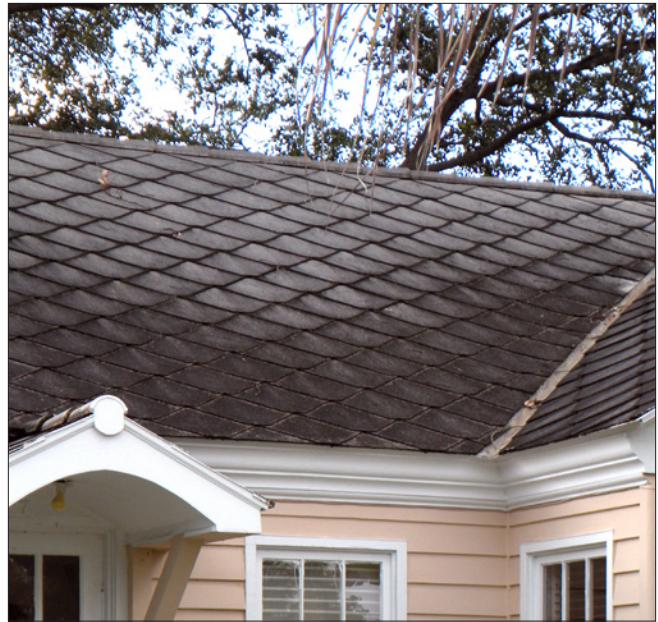
Although asbestos roofing was available in a number of different patterns, diamond-shaped shingles, such as those illustrated above, were by far the most common.

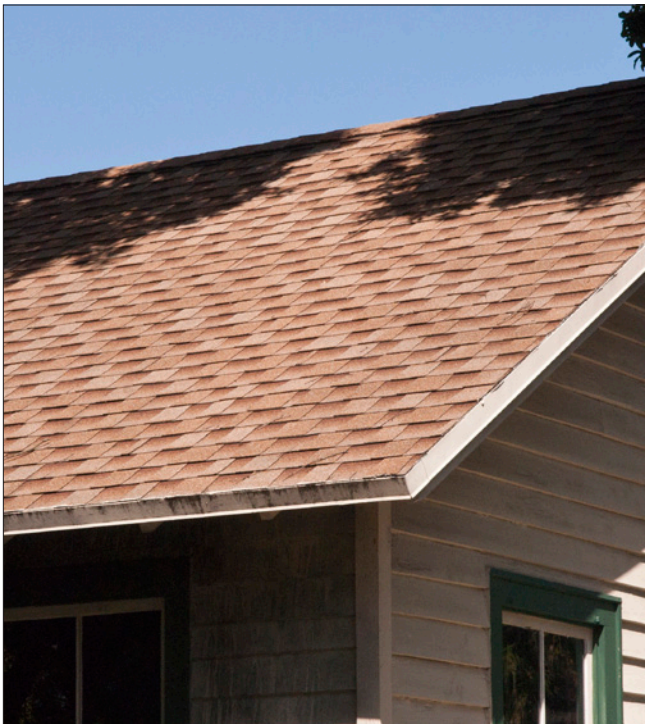
Asphalt shingles often replicate alternate materials such as wood shingles.

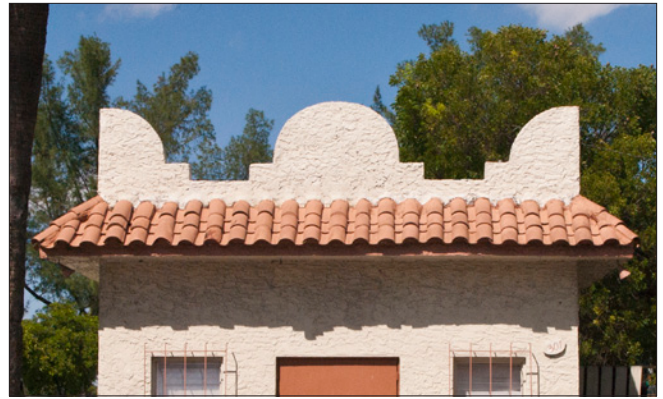
Flat roof are often hidden from view. In this case, a decorative parapet conceals the flat roof beyond. A terra cotta pent roof, located below the parapet, circles the building.

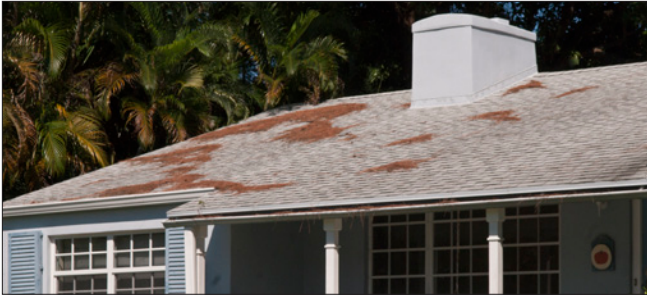
Flashing is typically made of thin sheet metal, formed to prevent water from entering a building at joints, intersections and changes of pitch. It is typically installed around chimneys, parapets, dormer windows, roof valleys, vents and intersections of porches, additions or bay windows. Flashing often fails before roof surfaces, particularly with more durable roofing such as slate, resulting in interior leaking. If the flashing deteriorates, it is possible to replace it without replacing the entire roof.

When replacing flashing or installing a new roof, it is important to select a flashing material that has an anticipated life span similar or longer than the roofing. Copper, terne, steel, lead and aluminum are all used for flashing. The longevity of each material is based upon its thickness, its propensity for deterioration from environmental conditions, and whether it is galvanized, treated or coated. Generally, copper has the longest life span, followed by steel, with aluminum being highly susceptible to punctures, tears and galvanic reaction with other metals. It is important to verify that flashing materials are sympathetic and compatible with existing roofing materials, particularly metal roofs.

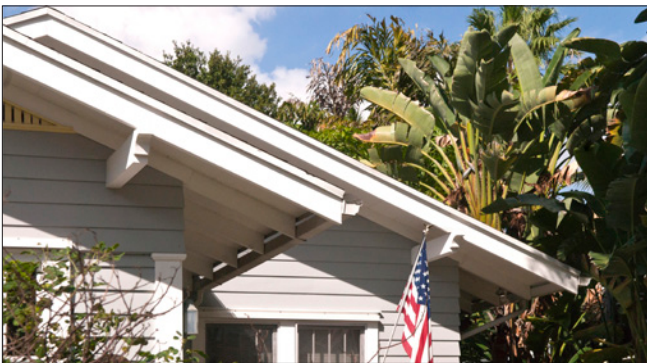
The extended eaves have exposed rafter tails and jigsaw-cut outriggers providing support.

Extended eaves extend the edge of the roof surface beyond the face of the building, discharging rain water away from the building wall. The style of an extended eave can be decorative, as in the case of a bungalow, or very plain, typical of a Mid-Century Modern building.

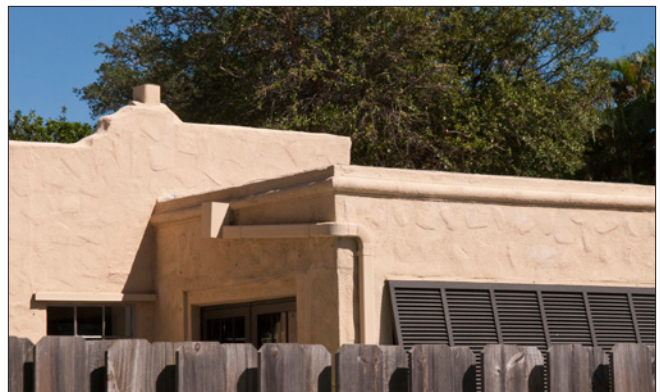
The downspout has been painted to match the color of the wall, reducing its visual prominence.

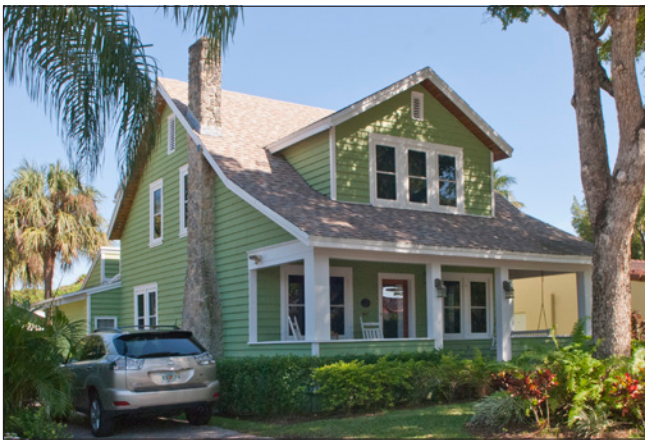
This Arts and Crafts style residence has a prominent front gable roof dormer and an exterior side elevation chimney. Both the dormer and the chimney are appropriate for the building's style.

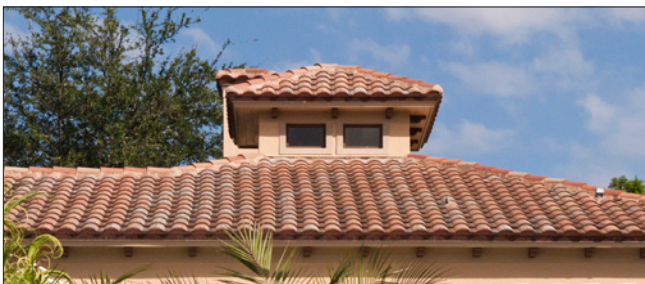
This cupola is topped by a hipped roof and includes windows at each face.

Cupolas, also known as monitors or belvederes, are structures that project up from the roof, used for ventilation with louvers, or as lookouts with windows. They can provide ventilation and light below, but can also serve as a decorative feature on important residential, institutional or civic buildings.

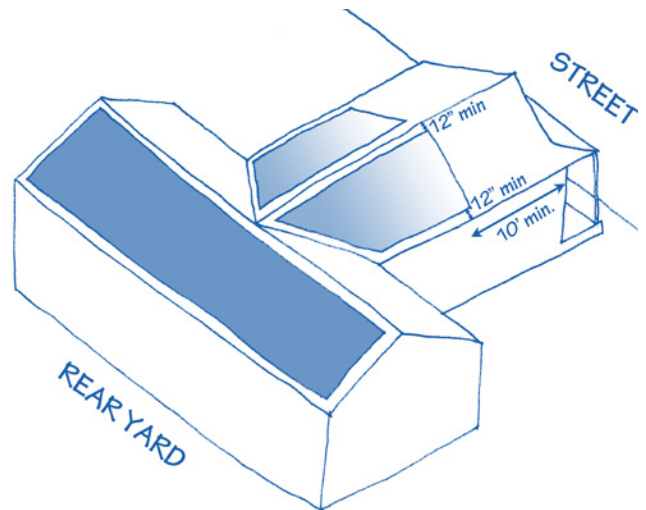
PREFERRED LOCATION FOR ROOF MOUNTED EQUIPMENT

- Applicants are encouraged to place all roof mounted equipment (including mechanical equipment; vents; television dishes and antennae; solar collectors and skylights) in a manner that is as visually unobtrusive as possible from the public view.
- Placement is encouraged facing a rear yard wherever possible. If it is not possible, placement as far back on a side slope as possible is preferred.
- Applicants are encouraged to install skylights and solar collectors so that they do not extend more than 8 inches above the roof surface.
