**City of Fort Lauderdale
Bridges Master Plan Update – A
(Single Ingress/Egress Bridges)**

June 30, 2023

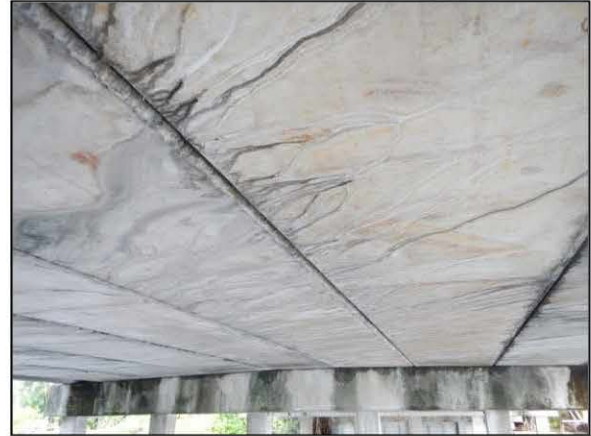
The majority of the City’s single ingress/egress bridges analyzed in this study are of prestressed concrete slab unit construction. For this type of bridge, 3 ft. to 4 ft. wide slab units are manufactured using standard forms. Prestressing strands are run through the formwork prior to pouring concrete. After the concrete is poured and hardens, the strands are tensioned to improve the structural capacity of the concrete units. All of the City’s bridges included in this study constructed after 1962 are of this construction type.

All of the City’s bridges are close to the waterline, with less than 9 feet clearance from the underside of the superstructure to the mean high water line. It is highly likely that the concrete is saturated with chlorides. For bridges of this type, where cracks and spalls already exist, making concrete spall repairs to areas where concrete is delaminated will address the primary anodic site (where the corrosion is greatest), but it will also create an anodic ring around the repair, because adjacent secondary anodic locations (areas with less corrosion present) become primary locations, which will eventually cause further concrete deterioration. For low lying coastal bridges on state roads, the FDOT State Materials Office Corrosion Research Laboratory personnel recommend replacement of the bridge once widespread deterioration is found, since the different repair methods they have attempted for such bridges have not stopped or significantly slowed the rate of deterioration.

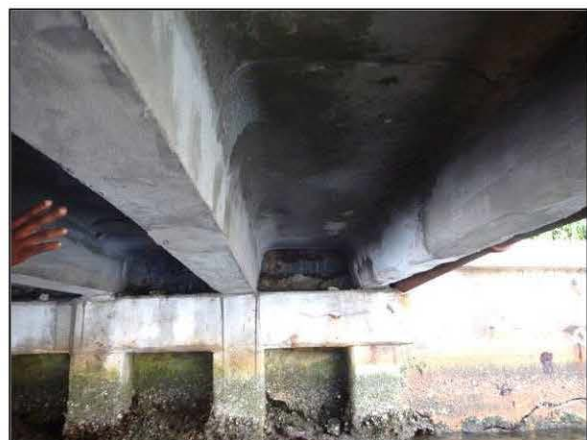
Seven bridges in this study consist of reinforced concrete double T-beams, which have thin webs and top flanges and are fabricated off-site using common forms into which reinforcing steel cages are constructed prior to the concrete being poured. The City’s bridges of this type were constructed between 1952 and 1958. These beam types commonly have less concrete between the exterior surface and the reinforcing steel, otherwise known as concrete cover, and are prone to corrosion when close to water due to chloride contamination and infiltration through load-induced cracking. Double T-beams are prone to the same limitations regarding repairs as prestressed concrete slab units

but have the additional problem that they tend to have less load carrying capacity. Once corrosion has started on the reinforcing steel and repeated repairs are needed, section loss to the internal reinforcing steel is very difficult to replace, for the main reason that there is often not enough development length available to splice in new bars and there isn't the space available within the thick webs to do so.

There are no cost-effective ways to strengthen T-beam bridges. For these reasons and given that all of the double T-beam bridges are over 50 years old with cracks and spalls to superstructure and substructure, all double T-beam bridges are recommended to be replaced during the 20-year study period.
