# City of Fort Lauderdale Historic Preservation Design Guidelines

## EXTERIOR MAINTENANCE

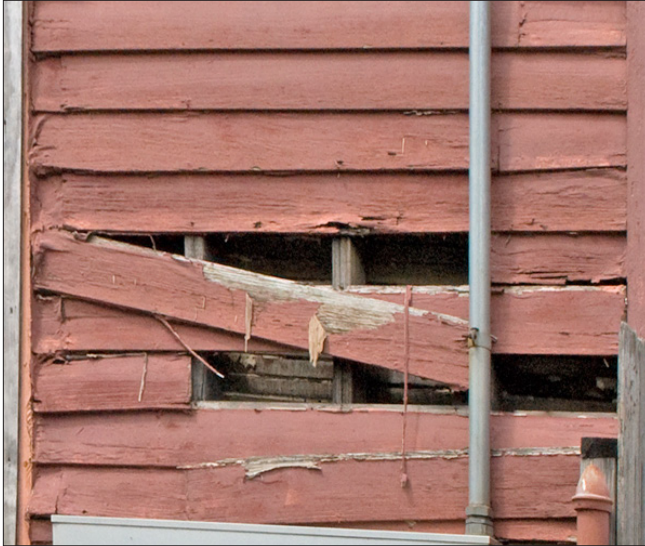
Portions of the siding are missing or dislodged, exposing the interior wall framing and interior plaster lath to the elements. Openings in the wall can allow moisture penetration and result in rotting of structural framing.

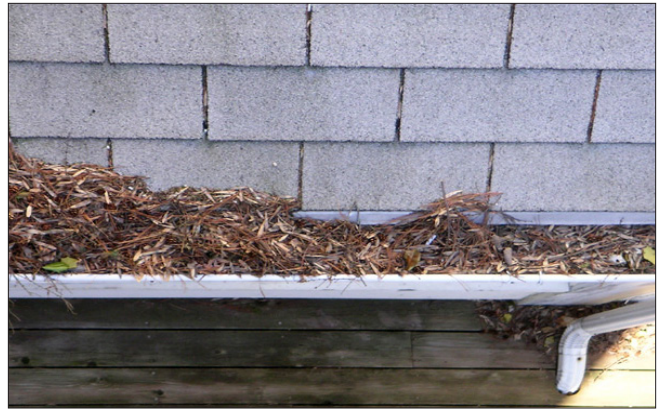
*The regular cleaning of gutters and downspouts is one of the most effective preventive maintenance tasks. Clean gutters and downspouts provide a means for moisture that accumulates on the roof to be directed away from the building without causing damage. This gutter is filled with leaves, twigs and debris, preventing clear drainage and allowing water to overflow the gutter and damage exterior wall surfaces. Gutters and downspouts should be cleaned at least twice each year to minimize potential problems.*

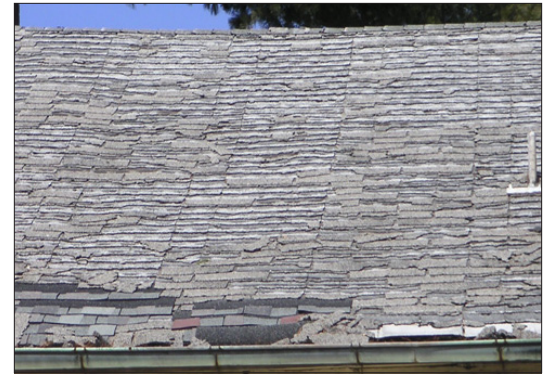
*The bow at the top of the roof suggests a structural problem that should be reviewed by a professional. The mineral granules of the asphalt shingles have worn away and shingles are broken and patching evident. The roof should be replaced after structural repairs are completed.*

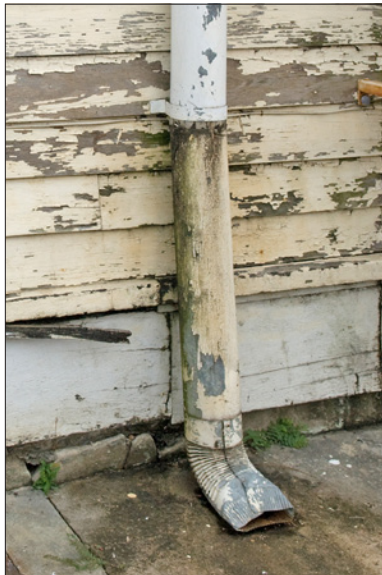
*The downspout is discharging immediately adjacent to the building onto a concrete surface. The bottom of the downspout is crushed, likely resulting in clogging. The storm water splashing onto the concrete surface can saturate the wood wall and masonry foundation. The wood adjacent to the downspout exhibits visible deterioration.*

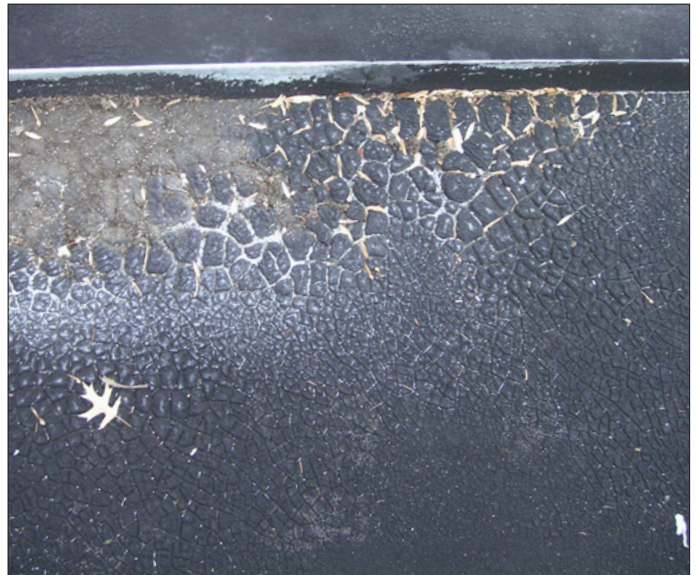
*The alligatored roof surface indicates deterioration and possible need for replacement.*

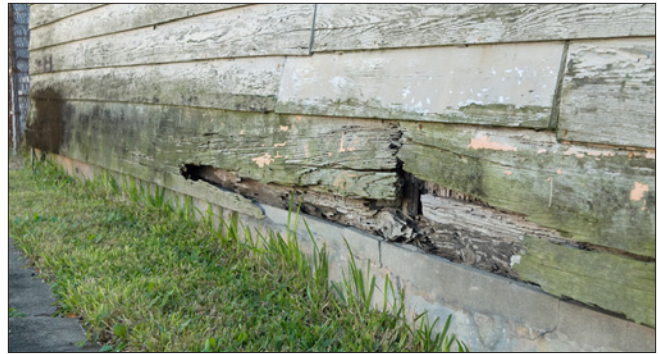
*Wood located on or next to a masonry foundation is more likely to absorb moisture and rot, as well as attract termites and pests.*

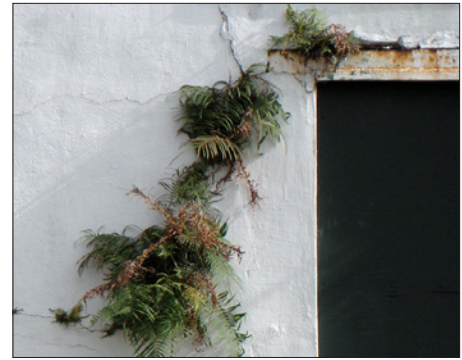
*The cracks in the stucco are supporting plant growth, suggesting high moisture in the wall. Also note the rusting lintel above the door.*

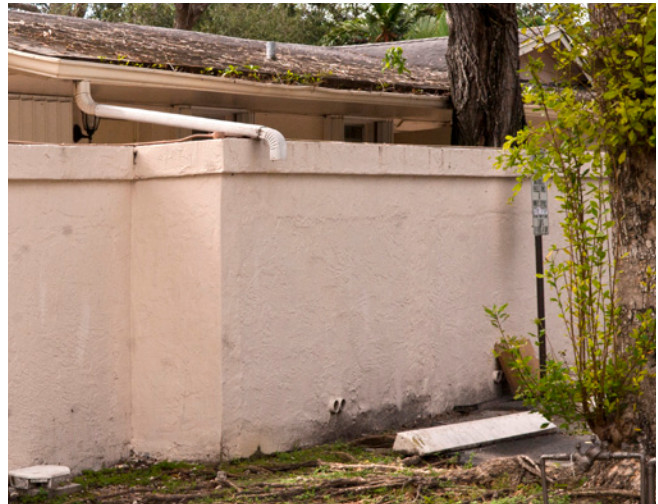
*The downspout is directed away from the building to the opposite side of the landscape wall and dark staining is visible along its base. Small plants are growing along the gutter and leaves and twigs are visible on the roof surface. A review of the water management around the building and site is recommended.*
