LAUDERTRAC

INFRASTRUCTURE AND RESILIENCE UPDATE

Tracking Progress on Fort Lauderdale Commission Priorities for 2022

September 2022

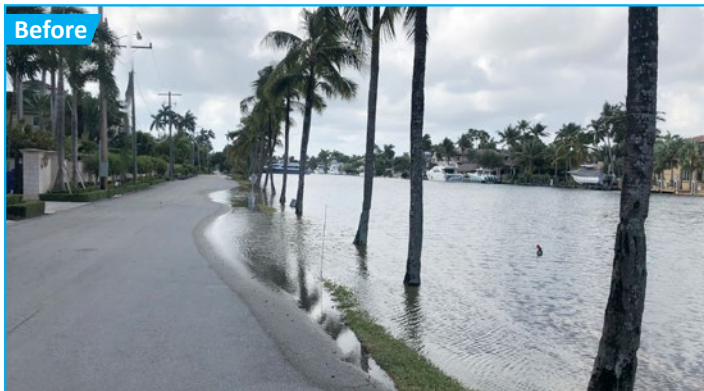
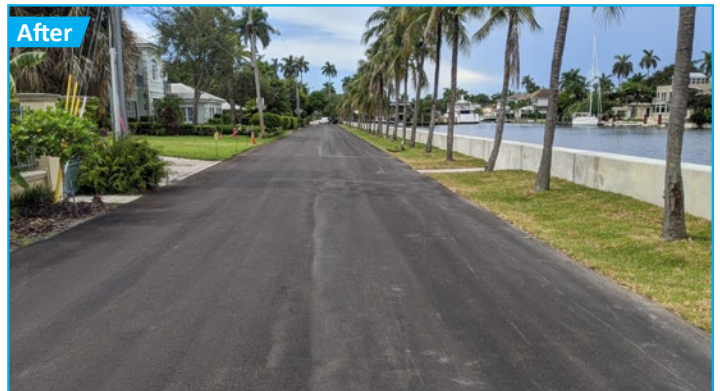
Isle of Palm Seawall before and after replacement.

To date, the City has made significant progress by rebuilding the public seawalls along Cordova Road and Isle of Palms to a higher elevation of five feet NAVD88, which is a reference standard for elevation. Additionally, two new seawalls are currently being installed on Hendricks Isle. These elevated seawalls will improve the community's resilience to sea level rise and flooding from storms and king tide events by more effectively restricting tidal waters from entering the City's roadways. In addition, future seawall improvements are planned for the seawalls along the south side of Las Olas Boulevard in the Las Olas Isles neighborhood, along SE 10 Street in Rio Vista, and along the Riverwalk.

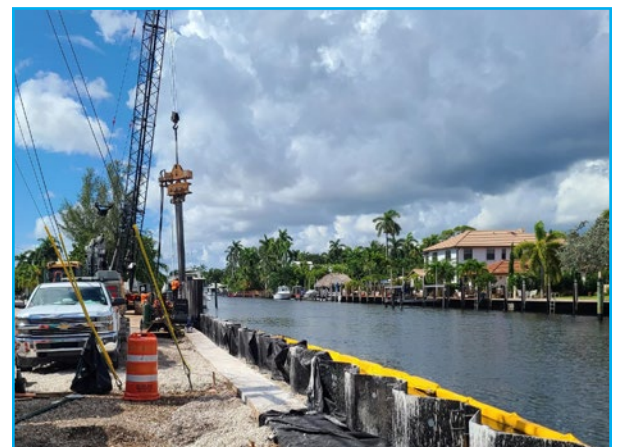
Hendricks Isles seawall under construction.

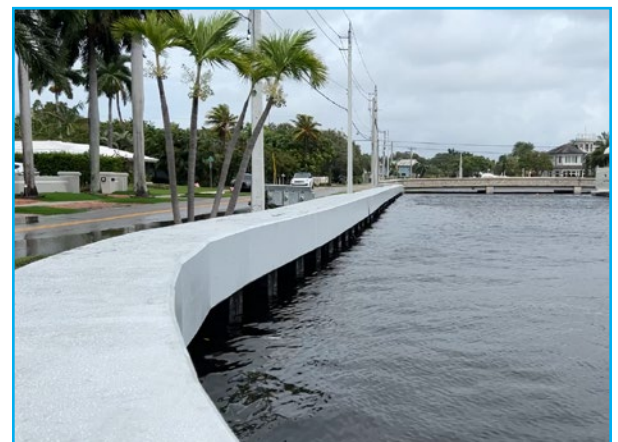
Newly elevated seawall along Cordova Road during Hurricane Ian.
